MONASH UNIVERSITY
THESIS ACCEPTED IN SATISFACTION OF THE
REQUIREMENTS FOR THE DEGREE OF
DOCTOR OF PHILOSOPHY

**Fracture Toughness and
Microstructure
Correlations in a Power
Generating Rotor**

The aim of this project was to derive new mechanical property correlations and microstructural indicators for improved assessment of the structural integrity of low alloy steel pressure equipment. The research program focused on a high pressure-intermediate pressure (HP-IP) rotor steel in the ex-service, de-embrittled and re-embrittled conditions.

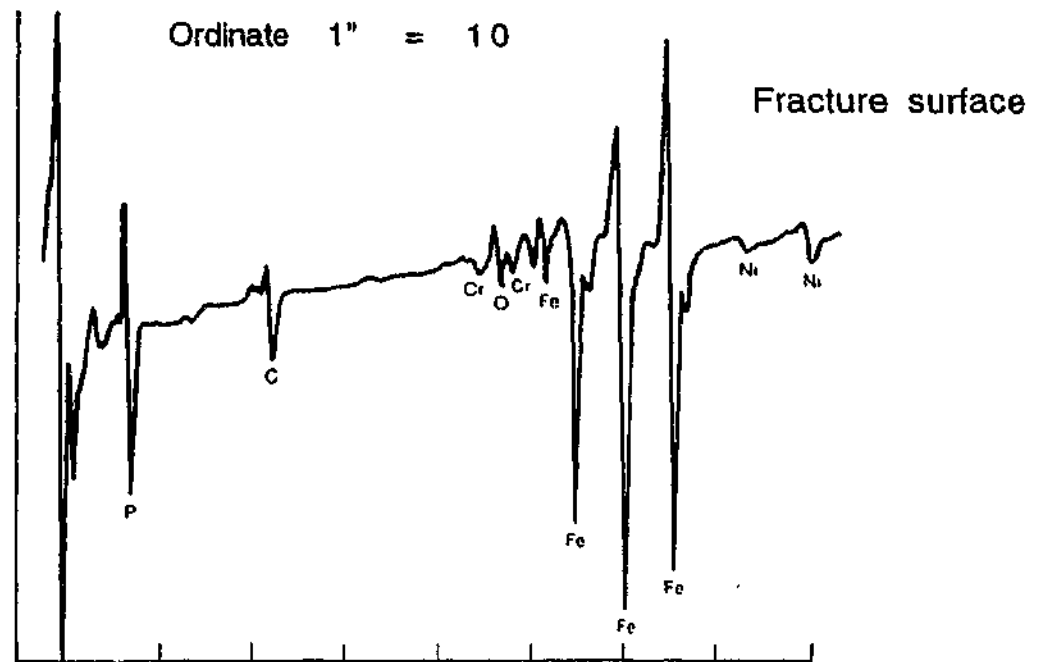
Figure 2.2 Auger spectra from the fracture surface of a Ni-Cr steel in the (a) embrittled and (b) non-embrittled conditions (after Viswanathan, 1989).

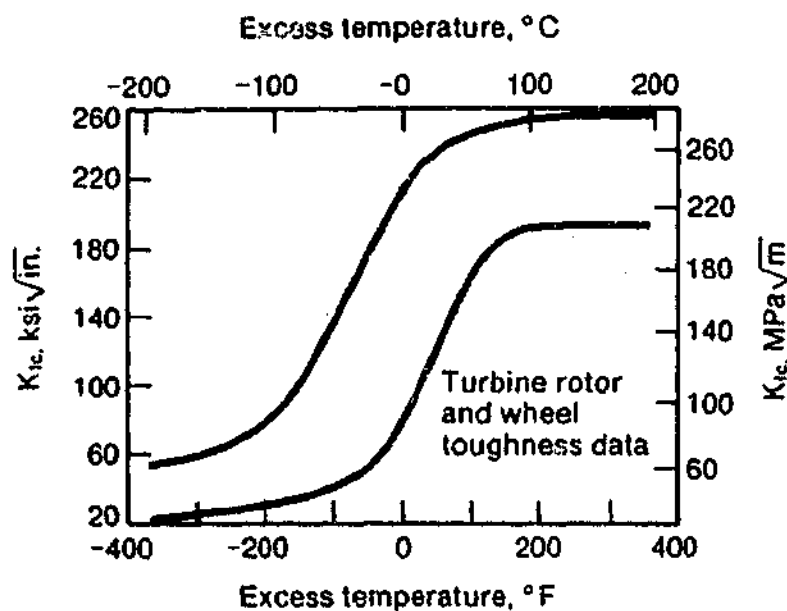
Figure 2.8 Correlation of K_{Ic} values with excess temperature for rotor and disk steels, defined as the temperature of interest minus the FATT at that temperature.

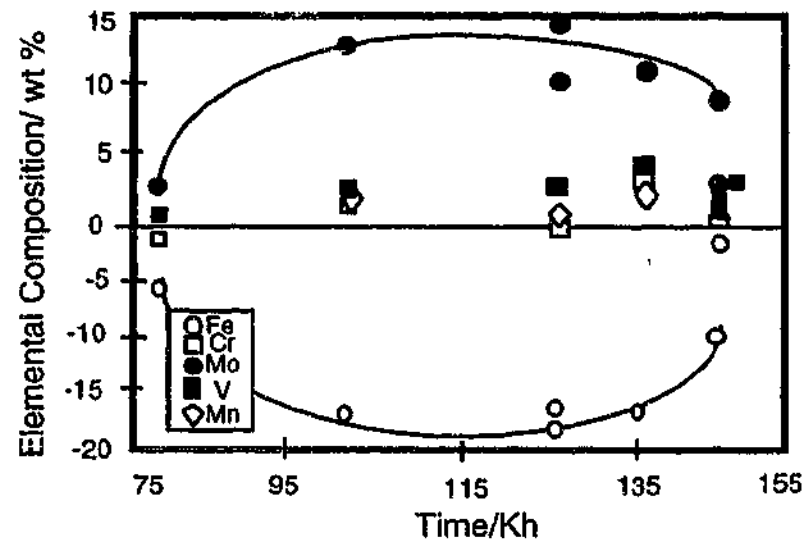
Figure 2.15. Change in average carbide compositions as a function of service exposure (after Mitchell and Moss, 1998).

Following identification of the carbides types using ATEM, X-ray analysis of precipitates extracted from a known volume was performed, so as to determine the relative carbide proportion and the total mass fraction of carbide. This can be used to back calculate the amount of (e.g.) Mo remaining in solution in the matrix. This allows an estimate of the potential scavenging effect for P and, together with other microstructural parameters, can indicate the susceptibility to temper embrittlement. Mitchell and Moss (1998) examined seven turbine generating rotors, including in-service and retired units. They reported an increase of hardness that was possibly due to carbide-induced loss of Mo in solid solution.

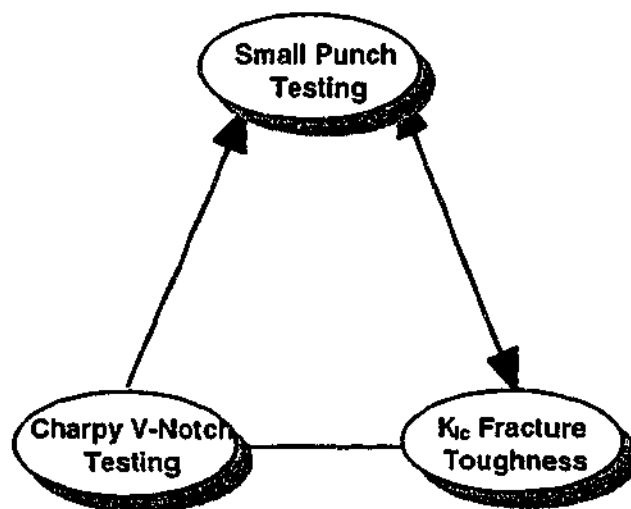
Figure 2.17 Triangular Mechanical Testing Correlations

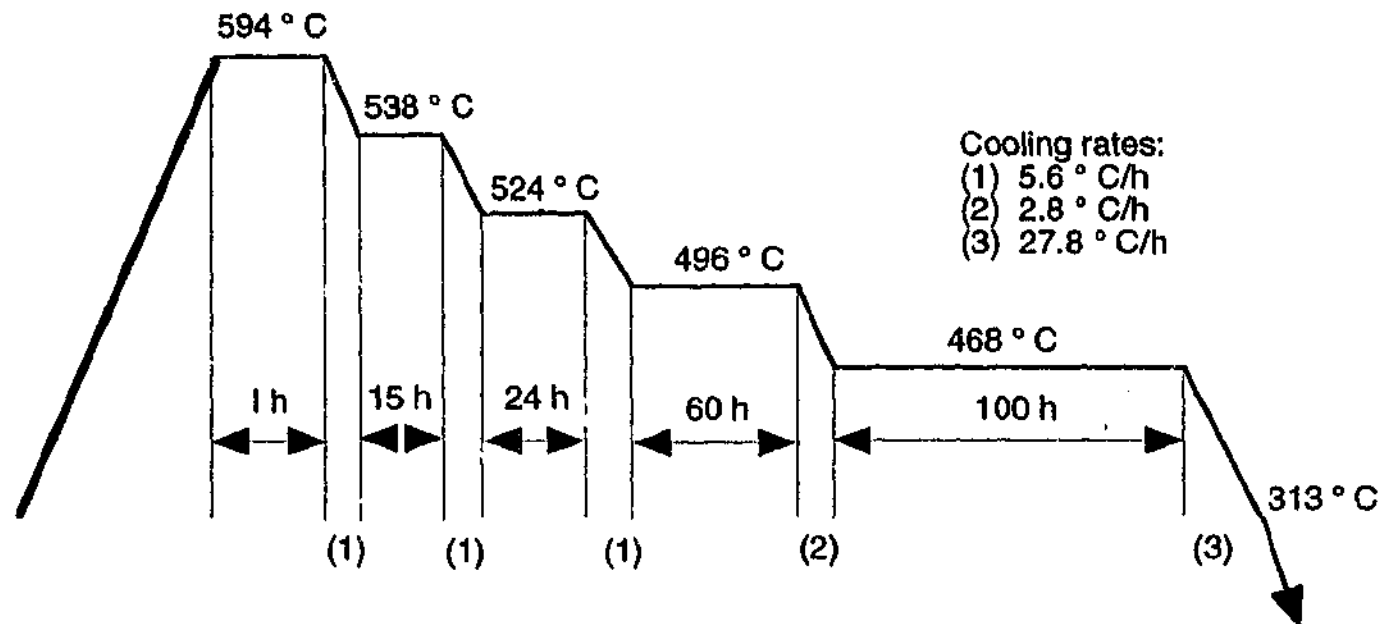
Figure 3.3: Step-cooling cycle

To evaluate the susceptibility of embrittlement, blocks cut from the core of stages 1, 3 and 12, were subjected to accelerated step-cooling procedure, known as a Gould thermal cycle (Gould, 1968). This treatment has been devised to induce a greater amount of embrittlement than any isothermal exposure of equivalent time. These heat treatments were designed to combine the favourable kinetics of embrittlement at high temperatures with the favourable thermodynamics of segregation at lower temperatures. The step-cooling procedure that was employed is shown in Fig. 3.3.

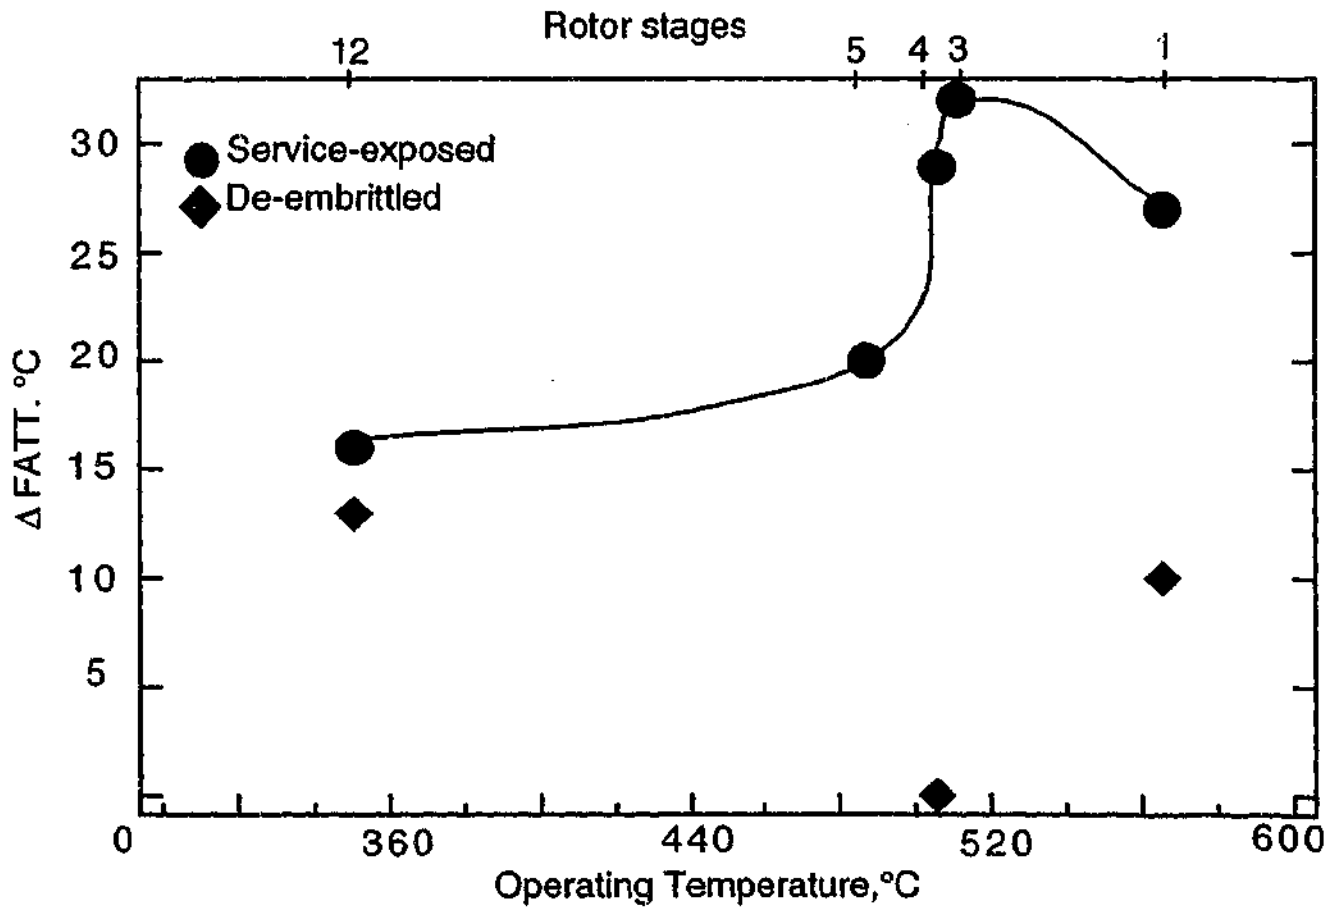
Figure 4.2 Relationship between the Δ FATT and operating temperature

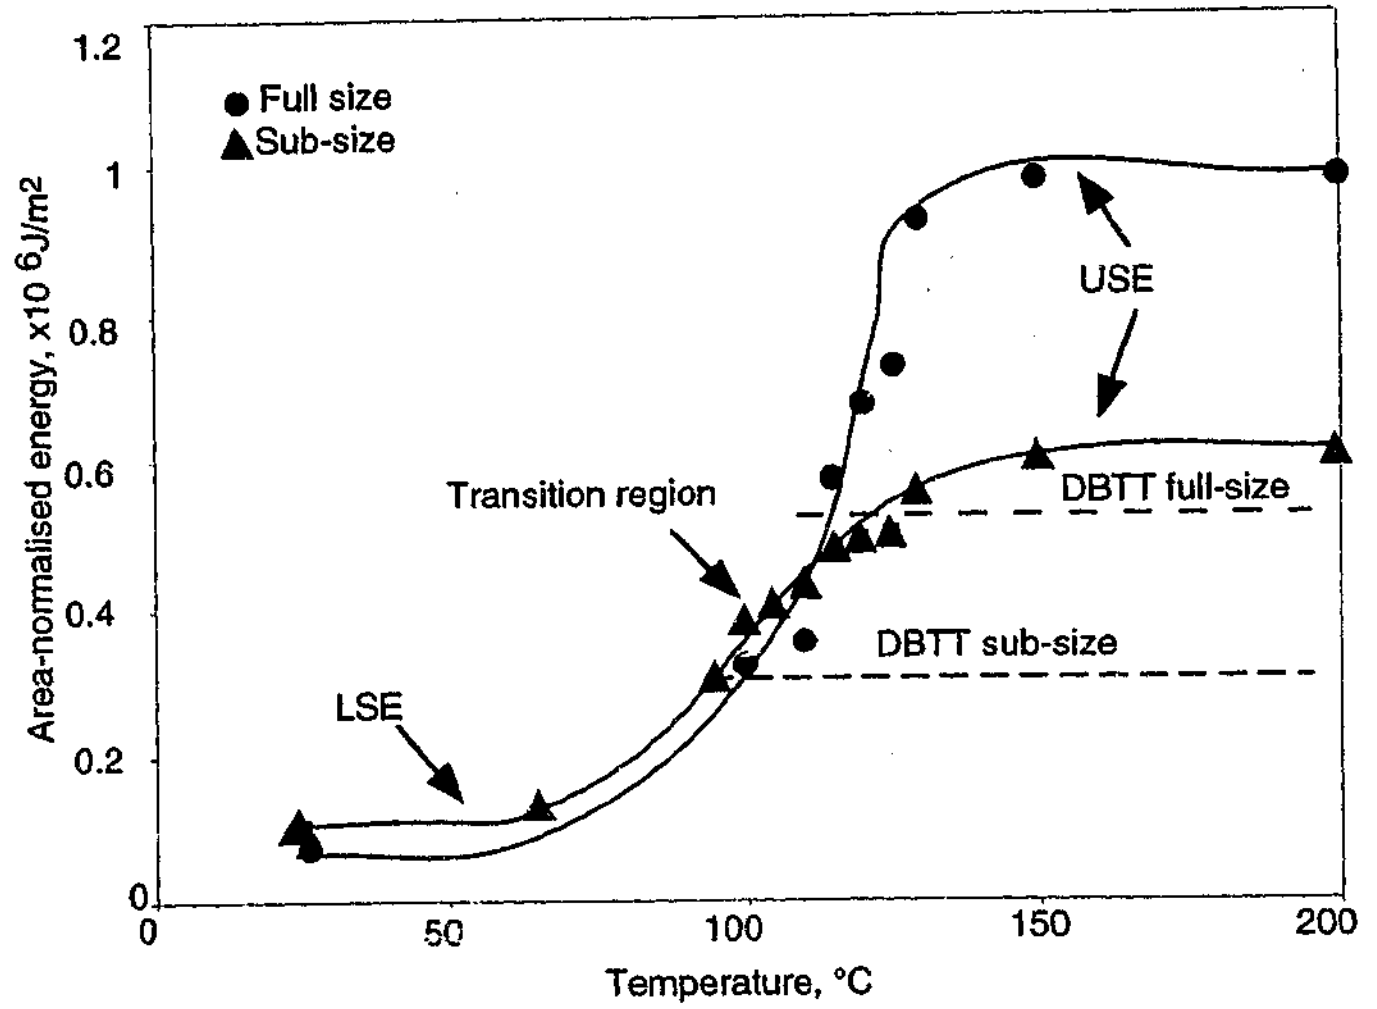
Figure 4.3 Area-normalisation of the absorbed energy curves for both full and sub-size specimens from stage 1 of the rotor

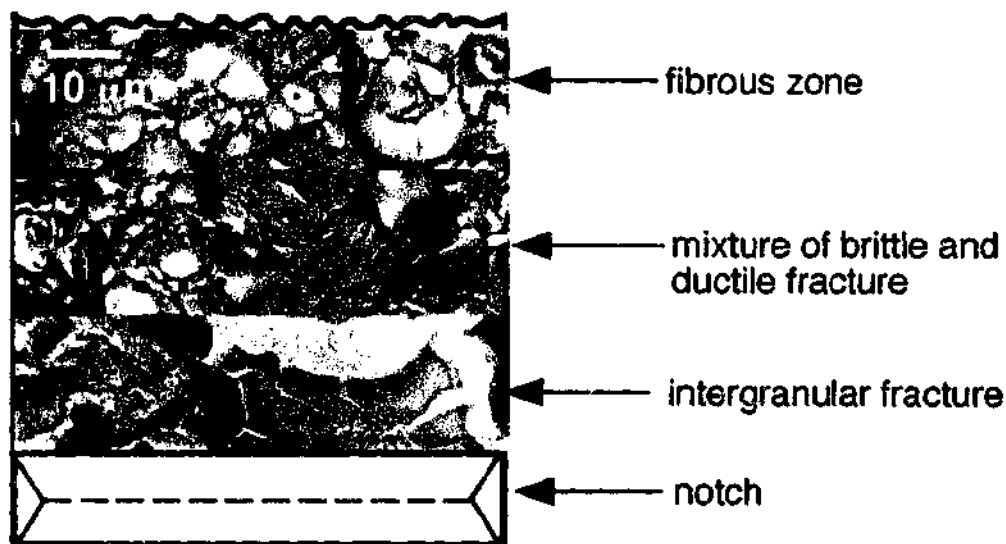
Figure 4.6: Schematic representation of the fracture surface observed in SEM

- p. 65, Table 4.2, legend: insert "SE- service-exposed, DE- de-embrittled".
- p. 68, para 1, line 8: delete "The present result indicates that the ductile failure by microvoid coalescence had occurred prior to the onset of brittle failure by cleavage" and insert "The brittle cleavage had occurred prior the ductile failure mode, which is supported by Fig.s4.5, 4.6.

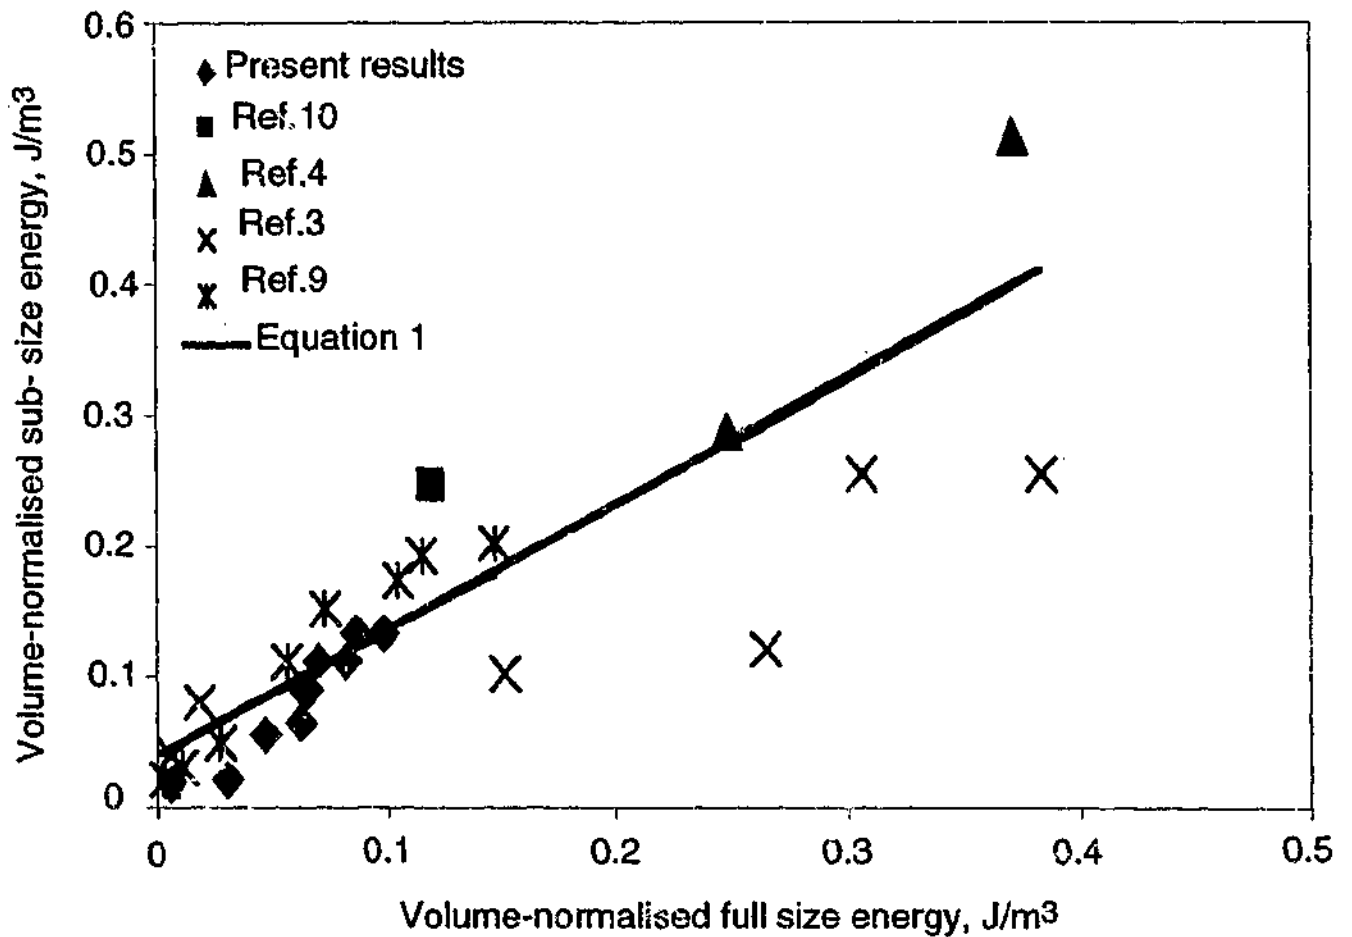
Figure 4.7 Volume-normalised full size energy, J/m³
